# DATALOGGERS AT THE PNSN

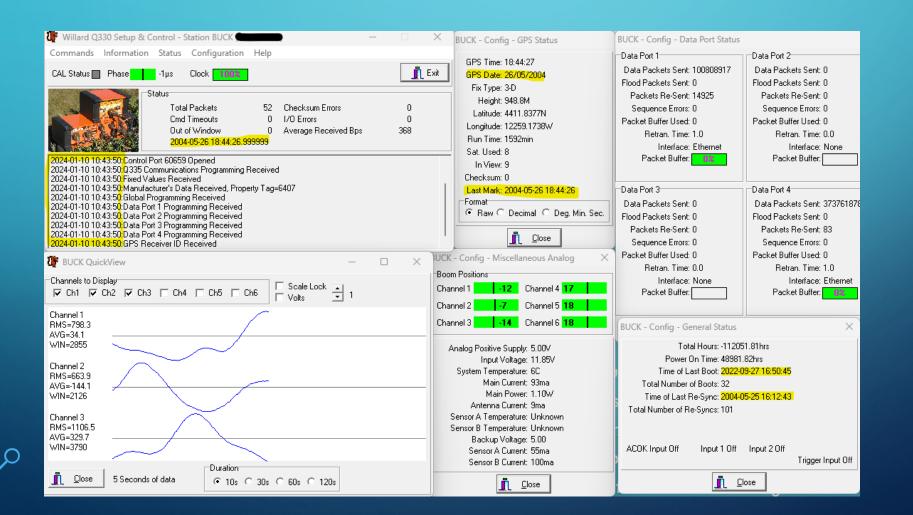
• Starting in August 2023 the most common problem we have faced with the S+ is the GPS rollover. Several of our stations started dropping off in BUD monitor and SNW(SeisNetWatch) due to the GPS almanac being cleared. This was caused by a lengthy power failure and/or GPS Cold Start. Initially the cause was not apparent until we looked at the time stamps of the data packets. Within Willard, everything looked normal except in one location, the GPS status. The user messages showed the correct date/time but the GPS status showed Jan 1<sup>st</sup> 2004. Firmware and documentation available on the q330 website was a bit misleading and vague when it came to the S+, what seemed to be good to update the Baler, did not fix the GPS issue. Kinemetrics support was alerted to the issue and began working on a fix. Early October they had a new Baler update that would indeed fix this issue.

• The second part relating to this particular issue is the failure of the USB thumbdrives that came with these loggers. We received SanDisk Cruzer Glide 64GB sticks. They had a manufactured date of 2016 on them. What I started to see as part of the Update upload was that multiple units thumbdrives were inaccessible. In normal operation the data recorded on these would overwrite older data when usage reached 95%. On these older sticks though, they would essentially ignore that limit and fill completely to 100% and then become unmountable and inaccessible. The only real solution is to conduct a site visit and replace them with the new software package present on the new thumbdrive. This has become an inconvenient task as we approached Winter and plenty of our Q330S+ sites can become inaccessible due to weather in higher elevation locations. We currently have 55 Q330S+ sites in network. We are currently replacing all thumbdrives with 2 x 256GB sticks to hopefully stem off any future issues.

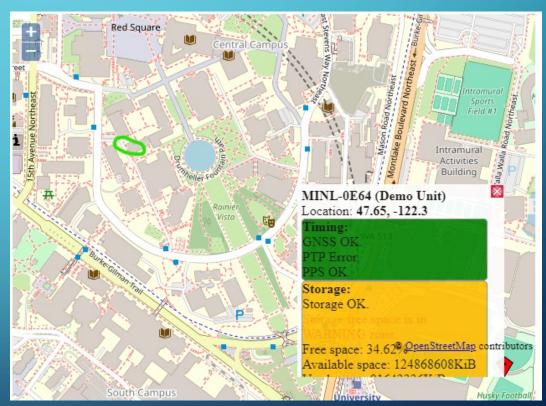
• While looking at the Discovery Control Centre one thing I did notice which I found odd was the GPS coords seemed to be a bit off as is apparent in this screenshot. Typically with other instruments there is a little bit of offset due to where our GPS antenna is located and the long cable run down to the basement to our repeaters, but it does at least get the external GPS antenna location. This map shows the red marker(GPS loc) on the East side of Husky Stadium and our location is the green circle which is about .55 miles away.
